WATER DAMAGE IN STRATA

UNDERSTANDING WATER DAMAGE CLAIMS

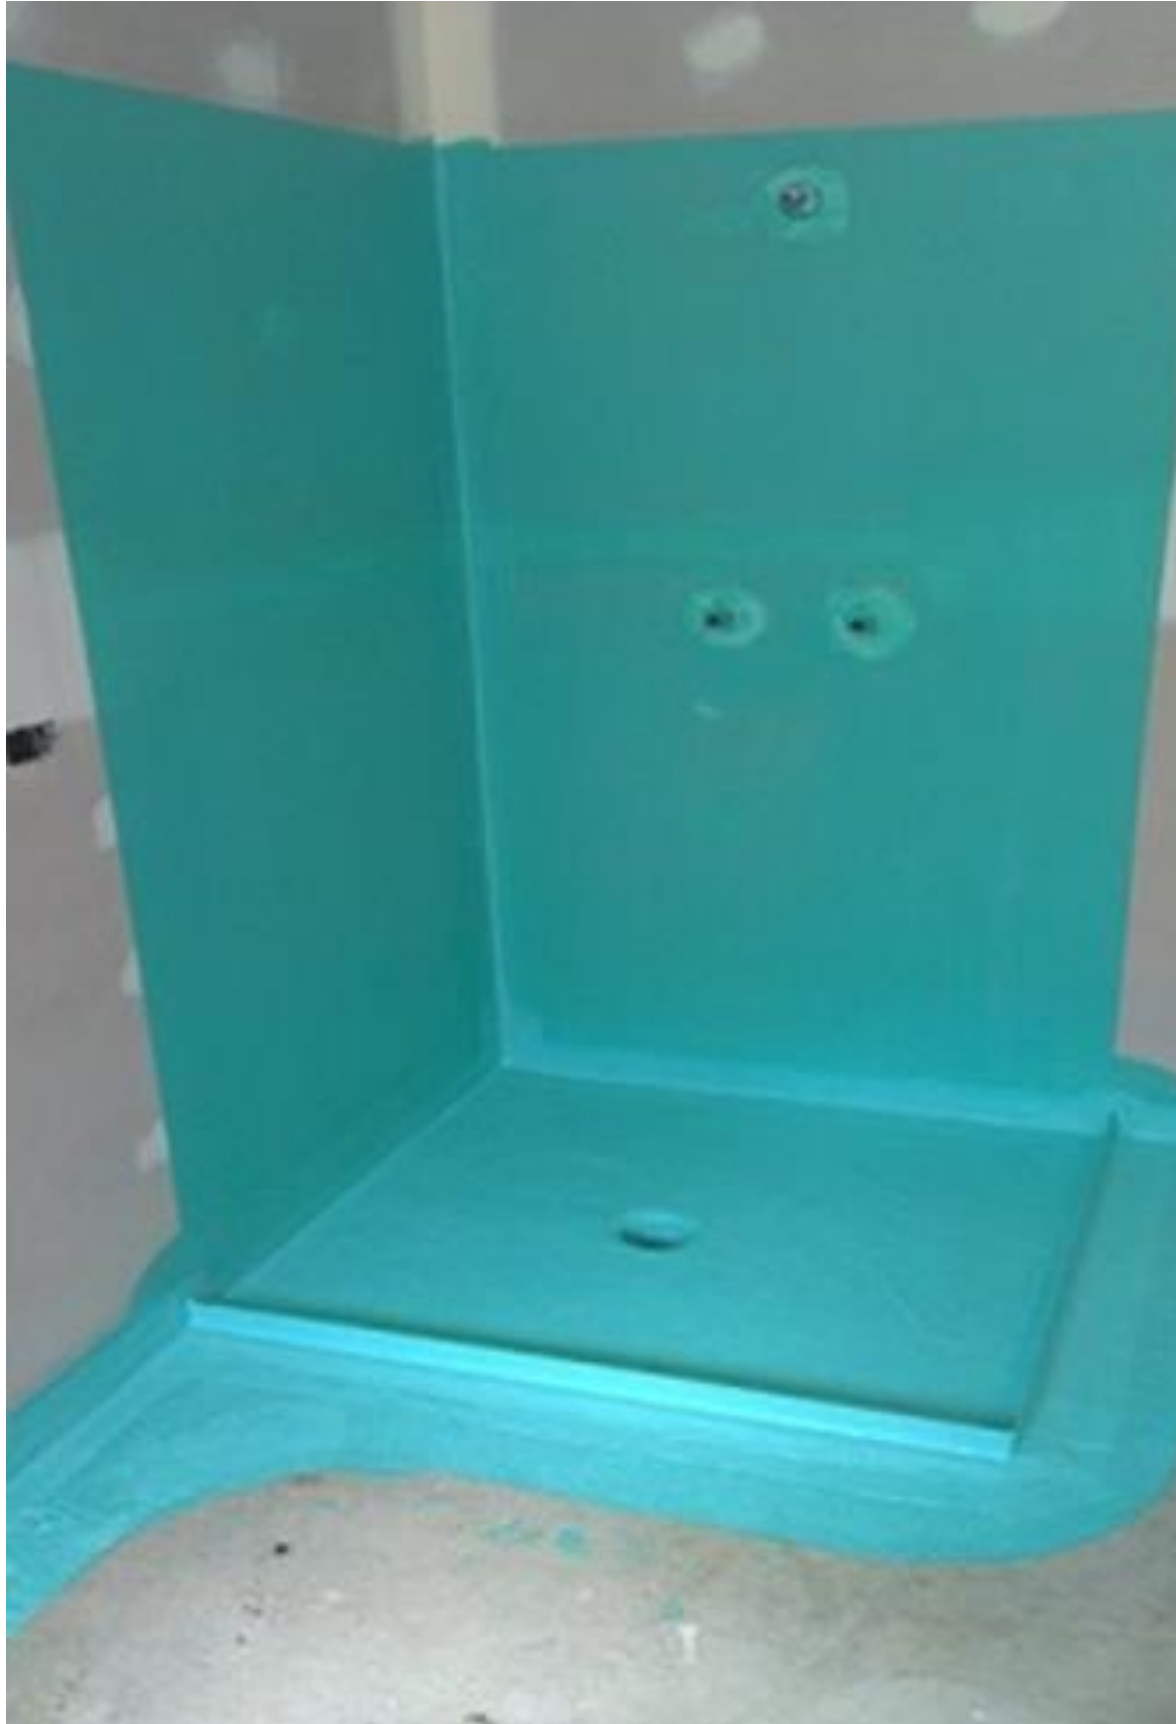
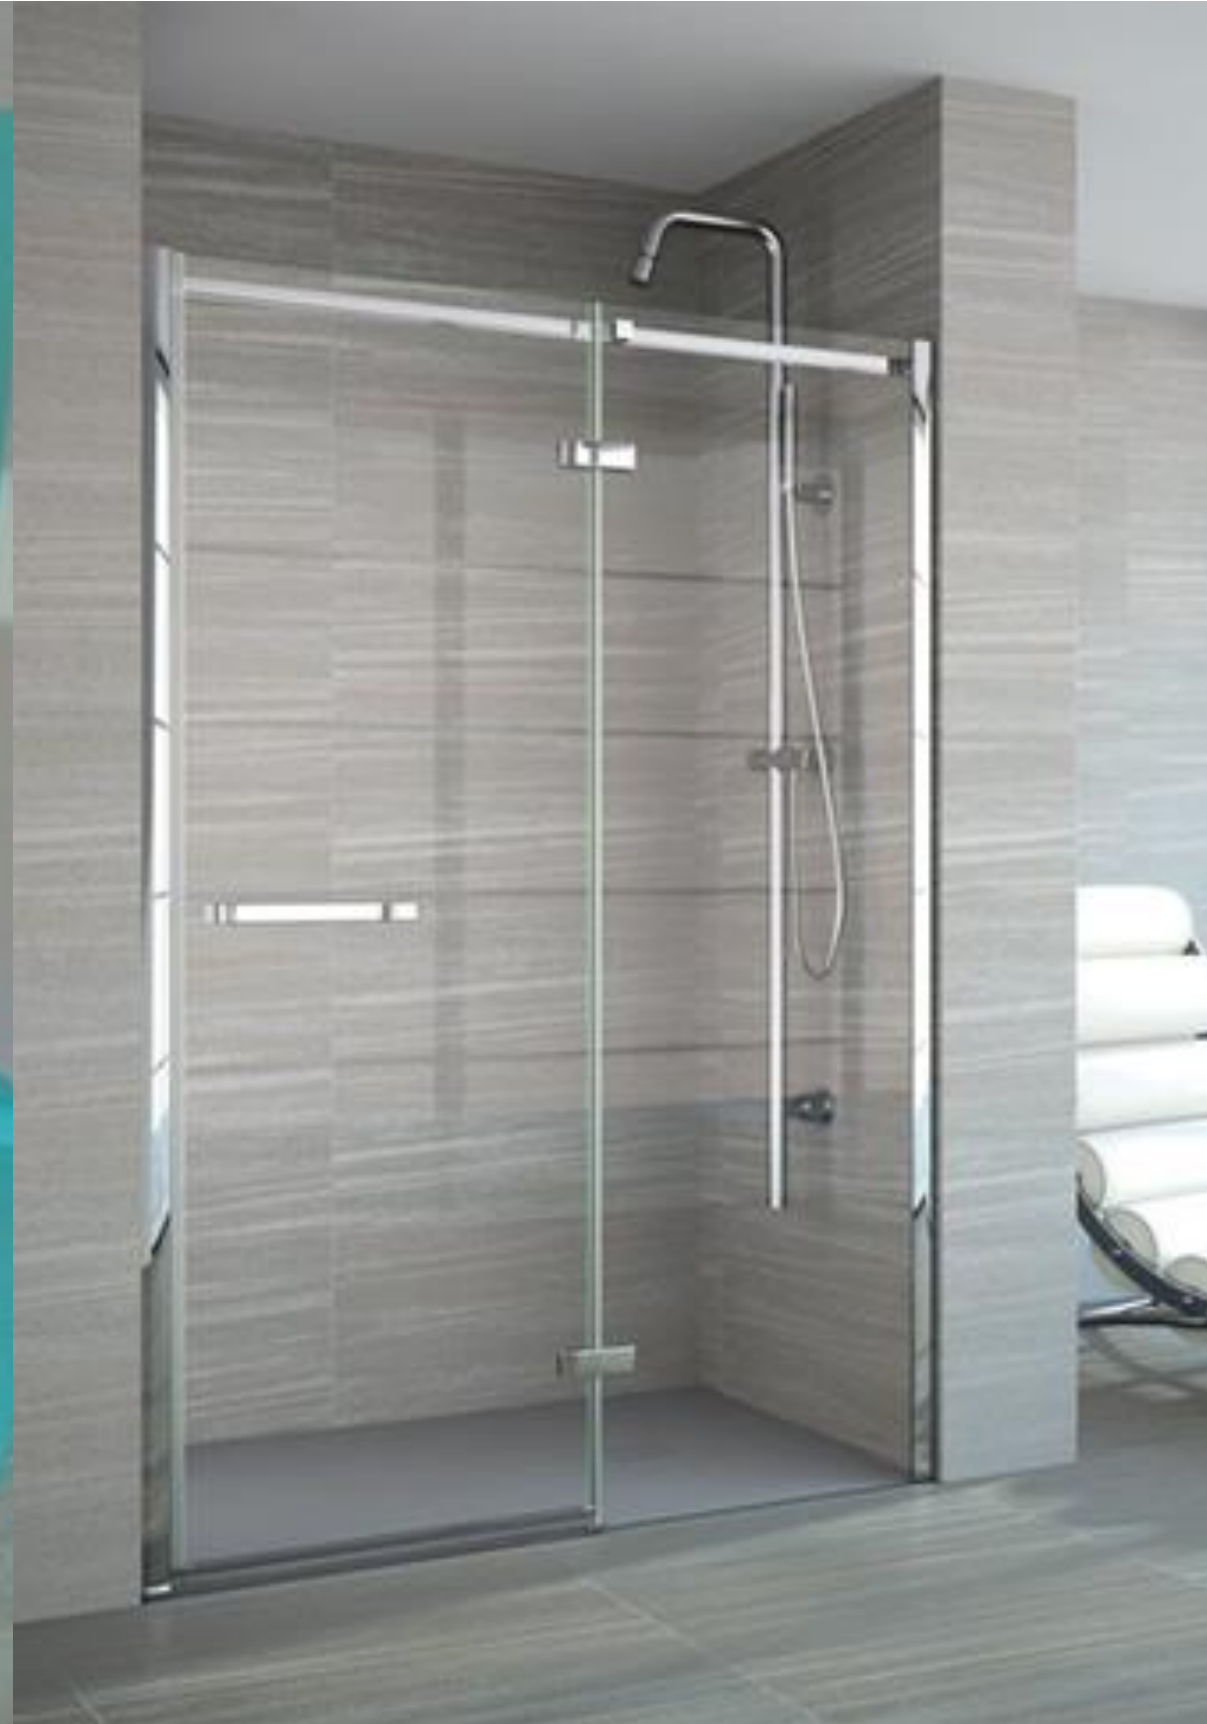
FAILED WATERPROOFING MEMBRANE

- Showers & Balconies
- Lifespan 25 years

- Repair damaged grout, apply new silicone spray over membranes (only when the membrane has not failed).
- Consider renovating bathroom every 25 years
- Builders warranty claim (within 6 years)

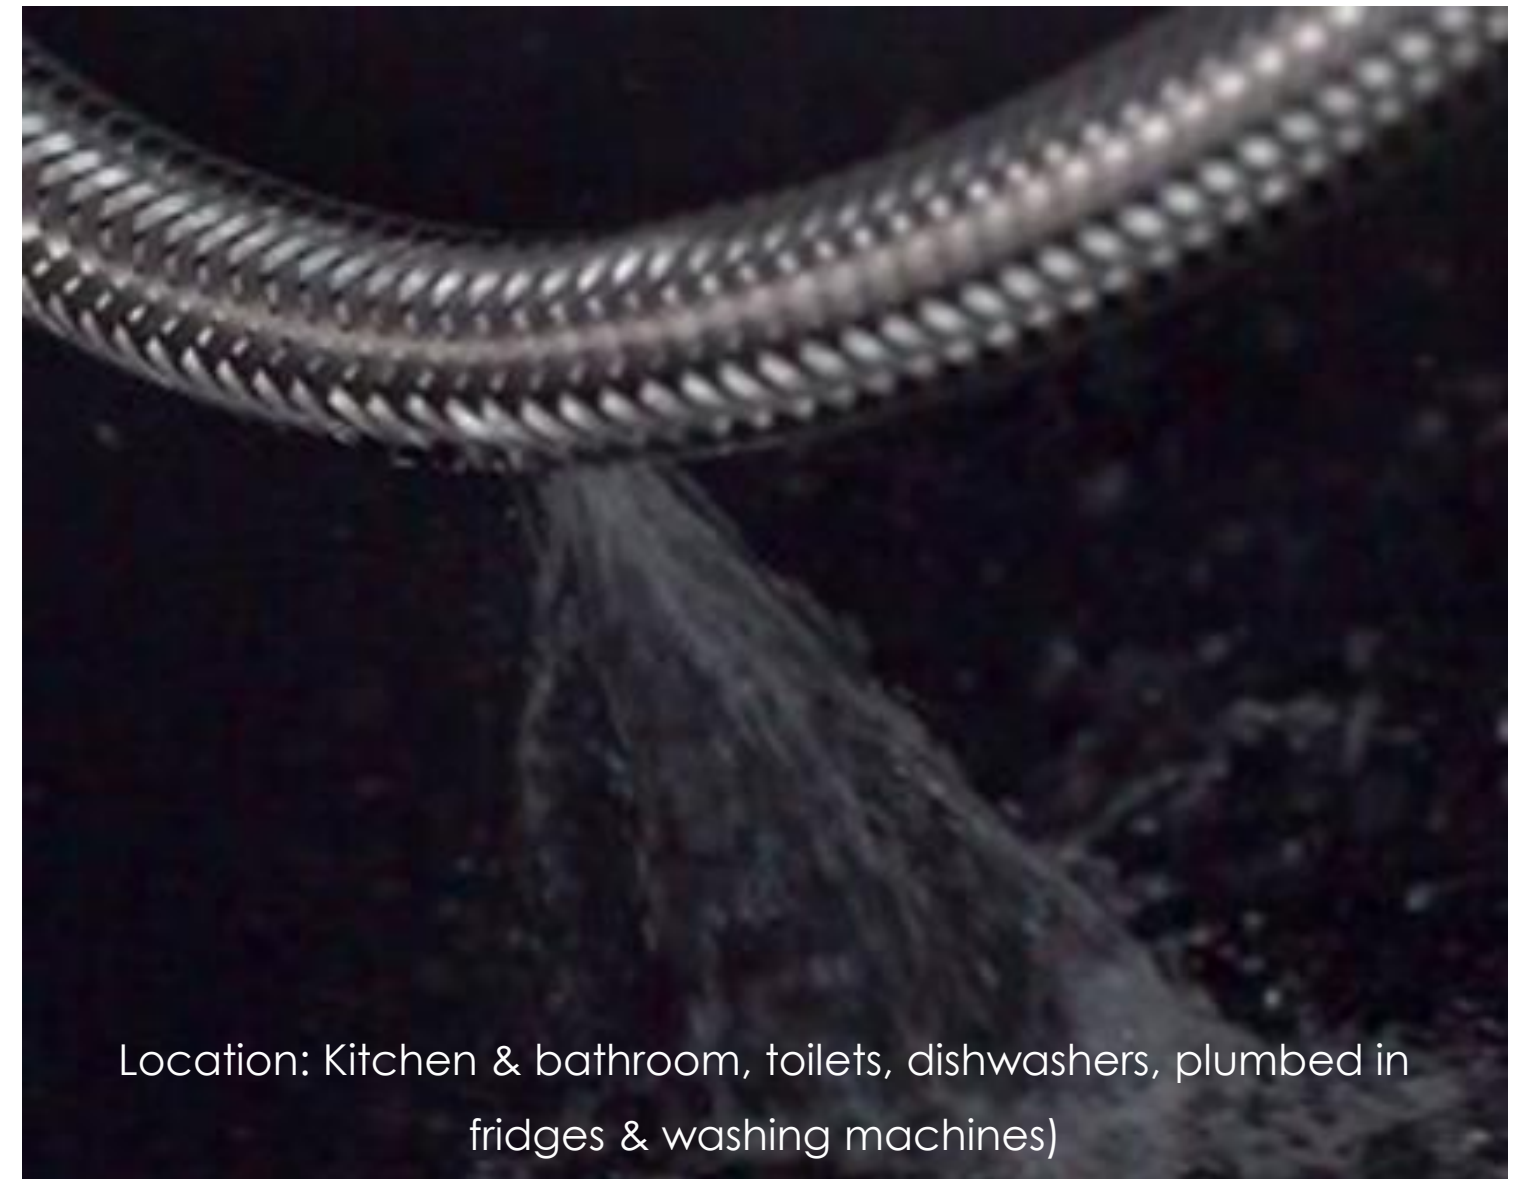
FLEXI HOSES

Location: Kitchen & bathroom, toilets, dishwashers, plumbed in fridges & washing machines)

- Check for rust & kinks
- Replace every 10 years
- Buy Australian Made
